# Near Miss

## Solar PV Installation to flat roof

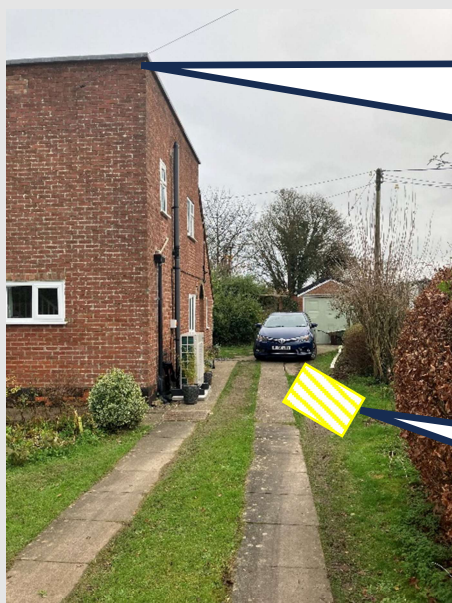
Flat roof space where solar panels were located and had moved during the high winds

Following the incident, the investigation revealed that no “weight” had been added to the Rensol Console+ as part of the installation procedure.

1. Checks are being made on all previous flat roof installations by the contractor to ensure that no other installations were affected.
2. Method Statement detail was incorrect as to the method of installation.
3. Scrutiny of sign off certificates are being undertaken for all flat roof installations to ensure that equipment/type of roof is correct on this documentation.
4. Hold Point – pictorial evidence is to be obtained by all installation teams for the contractor that “weight” has been added to the base of the unit and is recommended to ensure that this incident does not reoccur.
